To: Rockcrete Equipment	To: e-mail
Attention: Chris Buitendag	Time: 2 39 pm
From: Mervin Goslin	Date: 19 June 2017
Ref: <i>Y:\Projects 2017\Rockcrete\Rockseal Report.wpd</i>	
THIS DOCUMENT CONSISTS OF ..4.. SHEETS INCLUDING THIS PAGE

PROJECT: Rockseal Trials

Geopractica had been requested to undertake quality control testing on a Polymer type sealant which was to be applied to four Kimberlite samples originating from the Cullinan Diamond Mine.

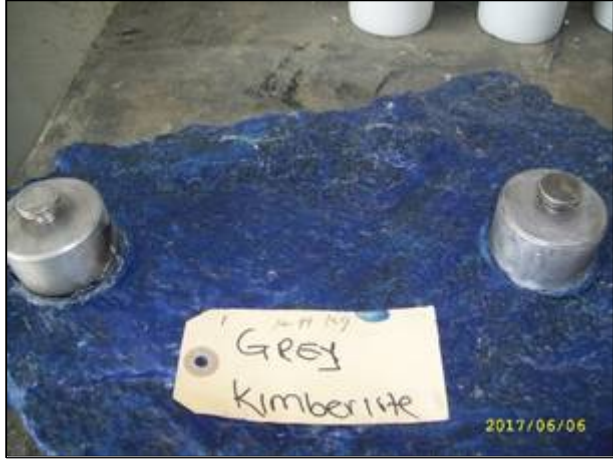
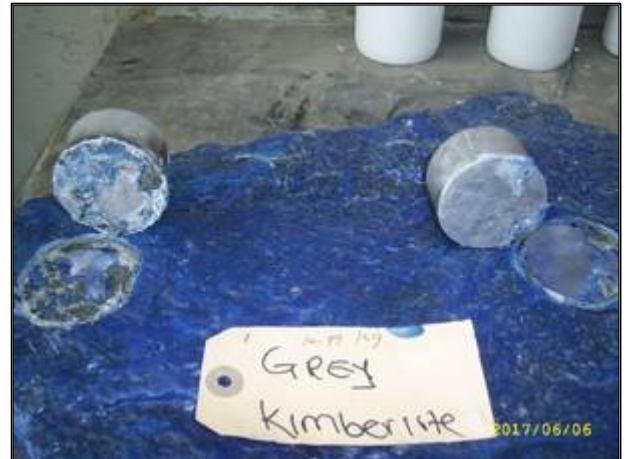
Refer to appendix 1 for photographs of the coated samples pre and post testing.

Table 1					
Sample Desc.	Sample Masses			Bond Strength	Failure Description
	Pre - coat	Post - coat	> 48 Hrs		
	(kg)	(kg)	(kg)	(MPa)	
Grey Kimberlite	14.99	15.09	15.09	1.25 / 1.25	Between sample & sealant
Brown Kimberlite	21.36	21.51	21.51	1.0 / 1.25	Between sample & sealant
Pale Piebald	6.02	6.06	6.06	1.0	Between dolly & sealant
Dark Piebald	2.05	2.07	2.07	2.0	Between dolly & sealant
